Water, sanitation and hygiene and sport in Papua New Guinea

Summary of findings of research for the PNG Sports Foundation

Policy
brief,
February
2019

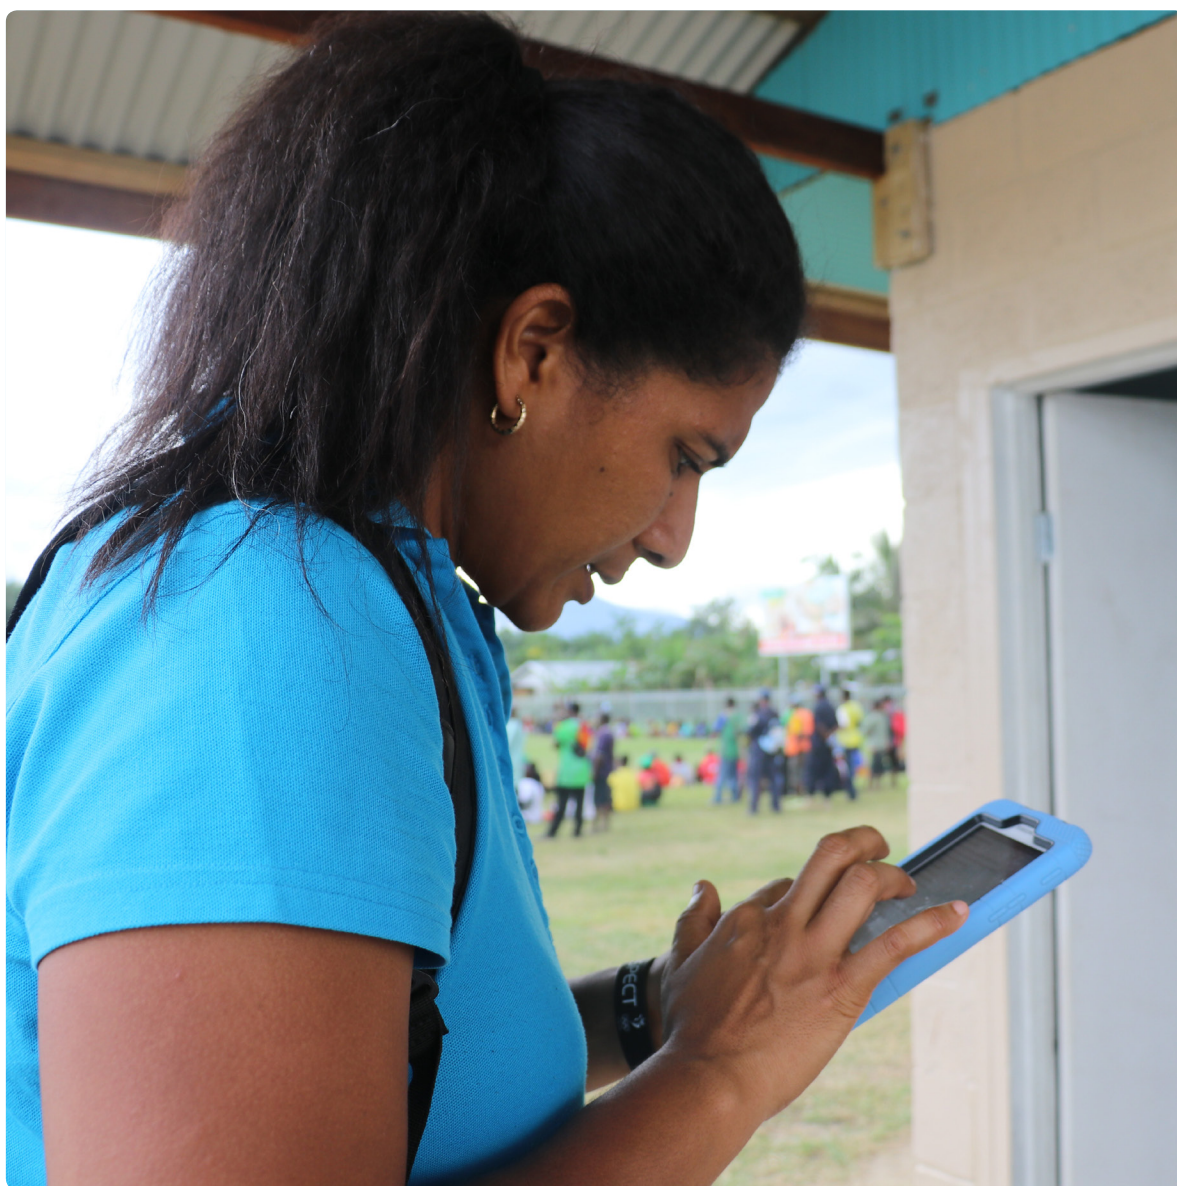
WaterAid staff member Lua Rikis collects data on the standard of WASH facilities at a PNG Games venue.

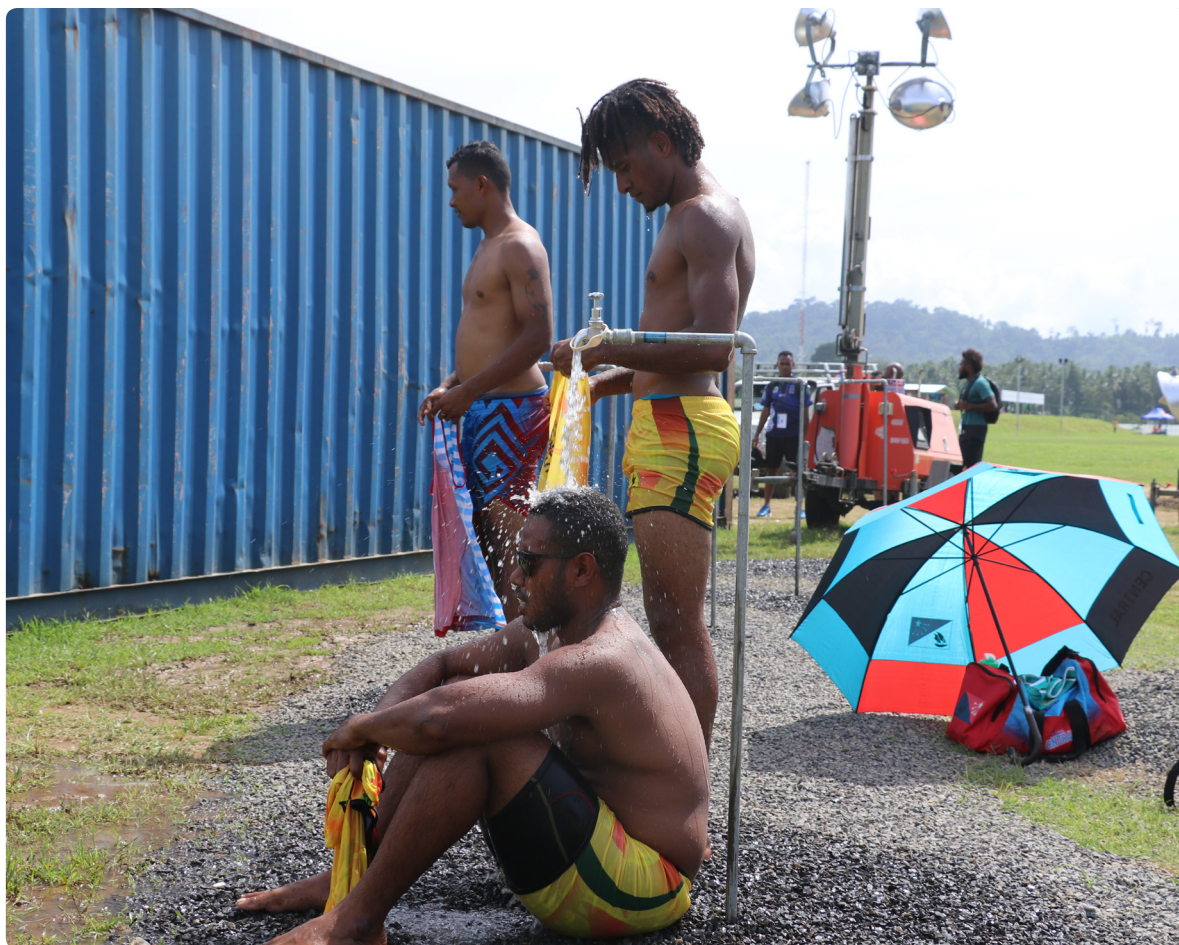
Athletes use a tapstand at San Remo to cool down between matches.

At least one tap was accessible at the five venues with onsite water supply. San Remo provided several tapstands for use by spectators and athletes. Tap stands were observed being used both for hydration and to cool down. With no water for sale at most venues, teams were bringing their own drinking water supply onsite.
